THE EFFECTS OF FRICTION IN THE CONTROL SYSTEM ON THE
HANDLING QUALITIES OF A C-54D AIRPLANE

Donald B. Talmage and John P. Reeder

WASHINGTON November 8, 1948

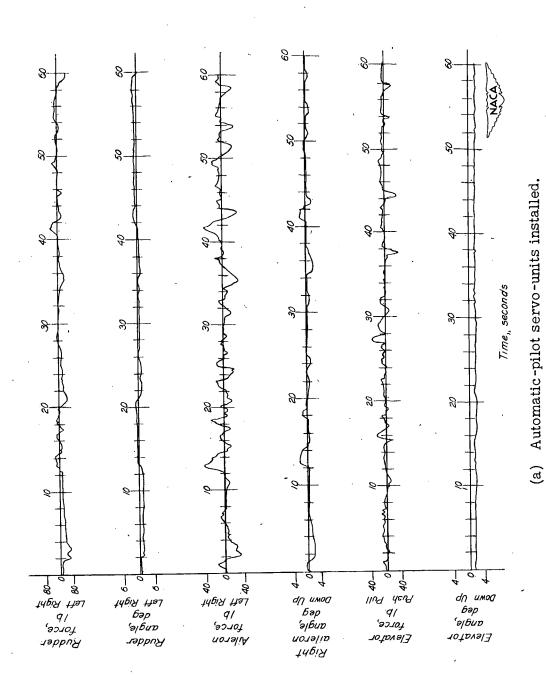
Several flight conditions were investigated both with the servounits in and with the servo-units out. Figure 1 presents time histories of the control forces and control movements during typical beam-bracketing operations, with the two different magnitudes of friction. Figure 2 presents time histories of typical normal power-off landings with the two different magnitudes of friction.

Time history of a beam-bracketing operation. C-54 airplane, clean condition 200 miles per hour. Figure 1.-

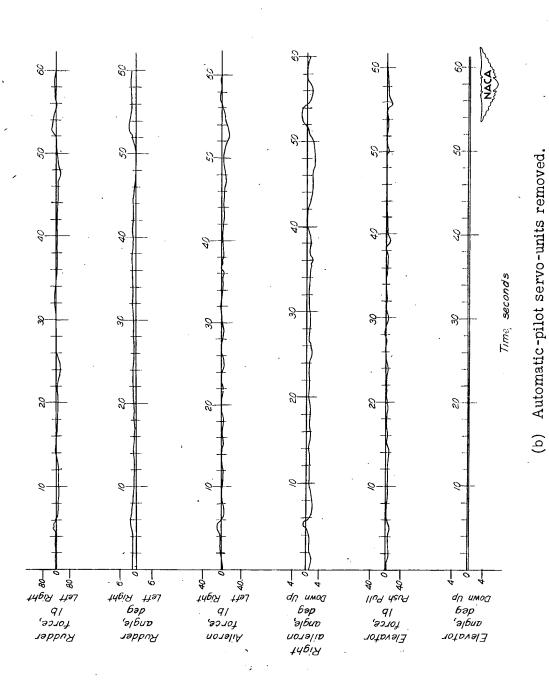
(a) Servo-units installed.

The preceding considerations indicate that the act of piloting with high friction in the control system becomes a continual process of quick force applications while moving the control very little. An example is presented in figure 1 which shows comparable time histories of beambracketing operations with high and low friction. The continual process of quick force applications with high friction is immediately apparent in figure 1(a).

The elevator force varies continually with little motion of the elevator; the aileron force, especially around 28 seconds and 46 seconds, varies without motion of the ailerons, and the rudder force, especially around 16 and 46 seconds, varies with little movement of the rudder. In figure 1(b) the continual quick force applications are nearly absent. The physical effort put forth by the pilot is therefore considerably increased when friction is present.

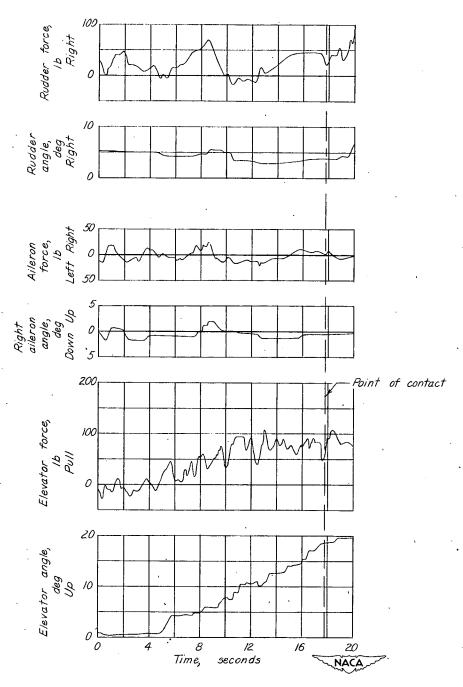
Aside from the standpoint of less physical work for the pilot, there is the more important consideration of making the control deflection follow closely the control force. Figure 2, which presents time histories of power-off landings with high and low control friction, shows how excessive friction can destroy the response of the control surface to applications of force at the control column. An equal amount of physical effort was involved in both landings, but the increased friction in figure 2(a) over that in figure 2(b) was sufficient to eliminate any correlation between the respective control forces and deflections.

Figure 2.- Time history of a landing. C-54 airplane, flaps full down, gear down, power off.

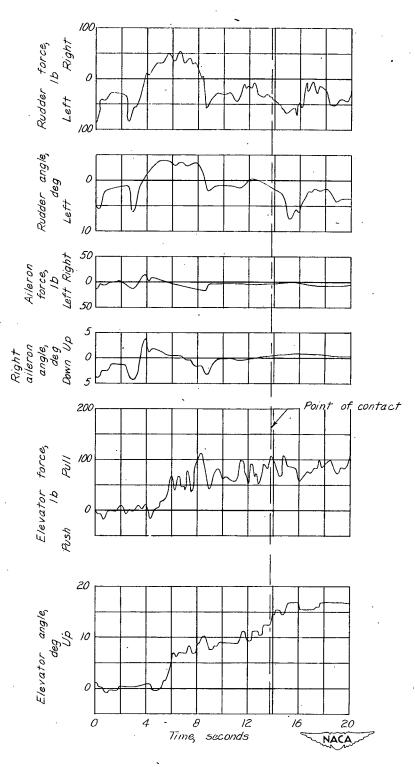
(b) Servo-units removed.

Figure 2.- Concluded.
